Images of recent mega mansion damage to farmland in Richmond

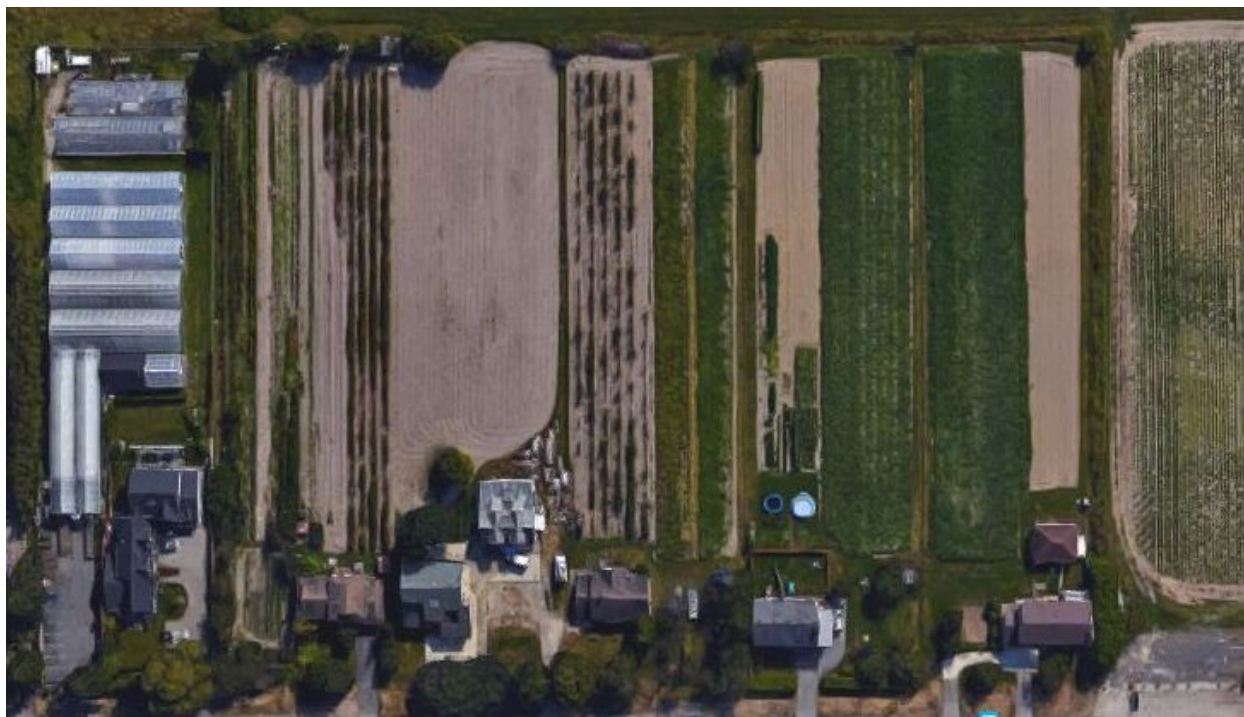
This aerial image is from June 2015 showing small farms along no. 2 road in Richmond. The houses are at a 25 metre setback from the road, the farm fields start at approximately 35 metres. Garage and some accessories are at 50 metres.

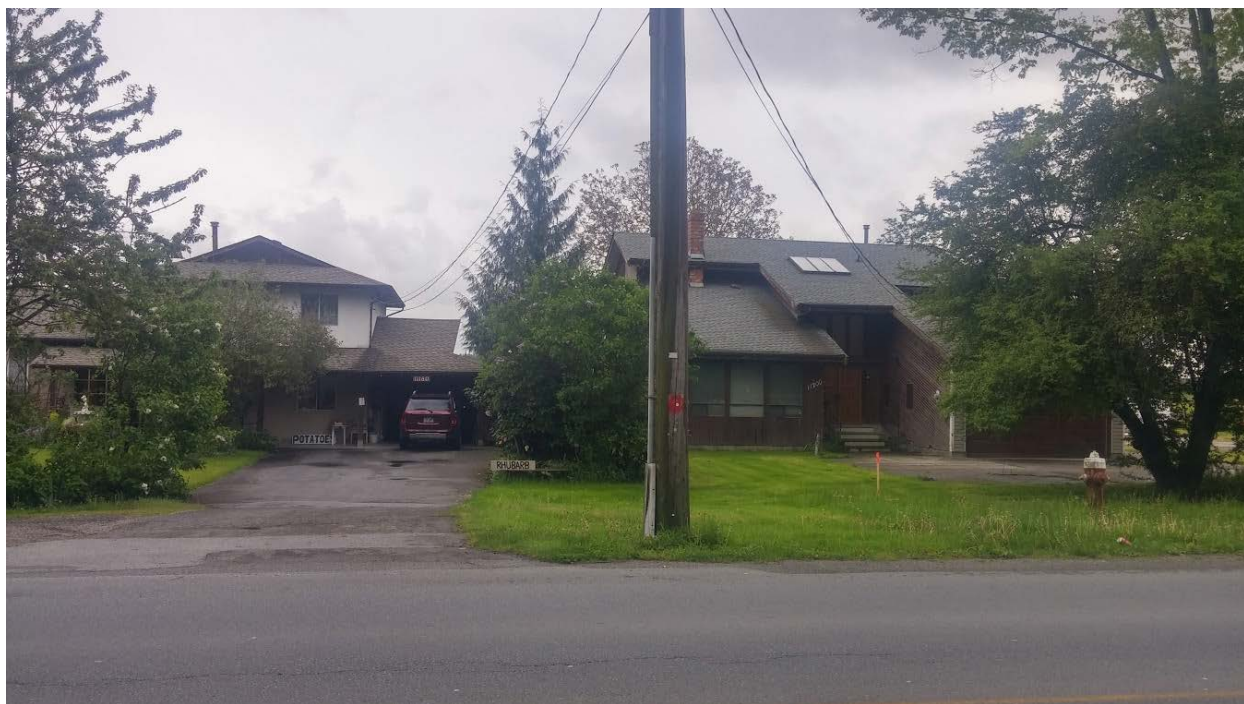
This is an active vegetable farm called Kaz farm. It is three 1.5 acre parcels farmed together. Each parcel has a small home and they are the same size as the houses across the street which are residential.

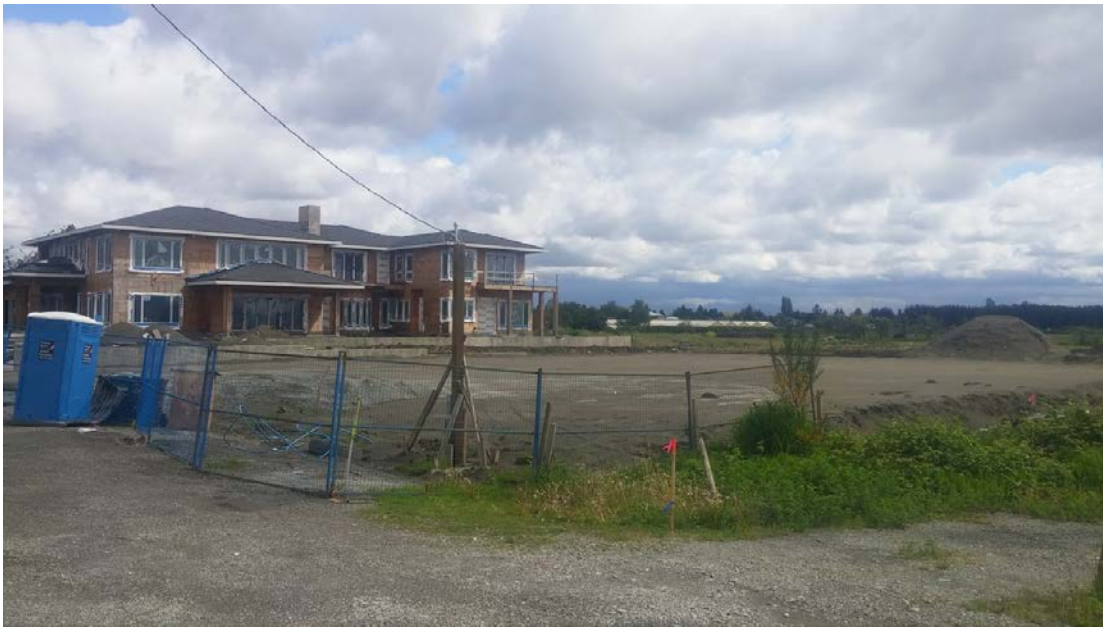
In the last two years, houses like this have been replacing the farms. This used to be the Village Garden Pumpkin patch, right next door to the Kaz farm. They are building to the maximum allowable, the houses are at the maximum 50 metres, and the home plate fill goes back 75 metres. These farms are only 150 metres deep so half of the length of the farm has been covered in fill. The fill has affected the drainage and crops on the Kaz farm.

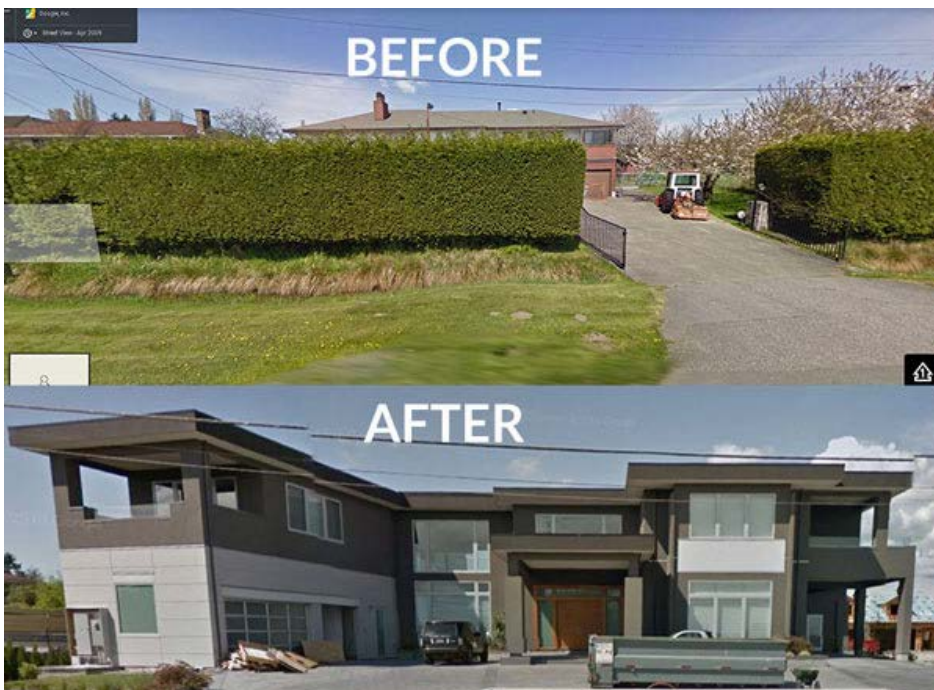
This house is approximately the size that is currently permitted in Richmond on any farm over 0.5 acres. Which is 11000 square feet, at a 50 metre setback, a 75 metre home plate setback, and septic field allowed outside of the home plate. This was a farm on Monteith just off of No.2 road in West Richmond which is all Class 1 clay farmland. When the homes are built the orchard trees and mature shrubs for the bees are all removed.

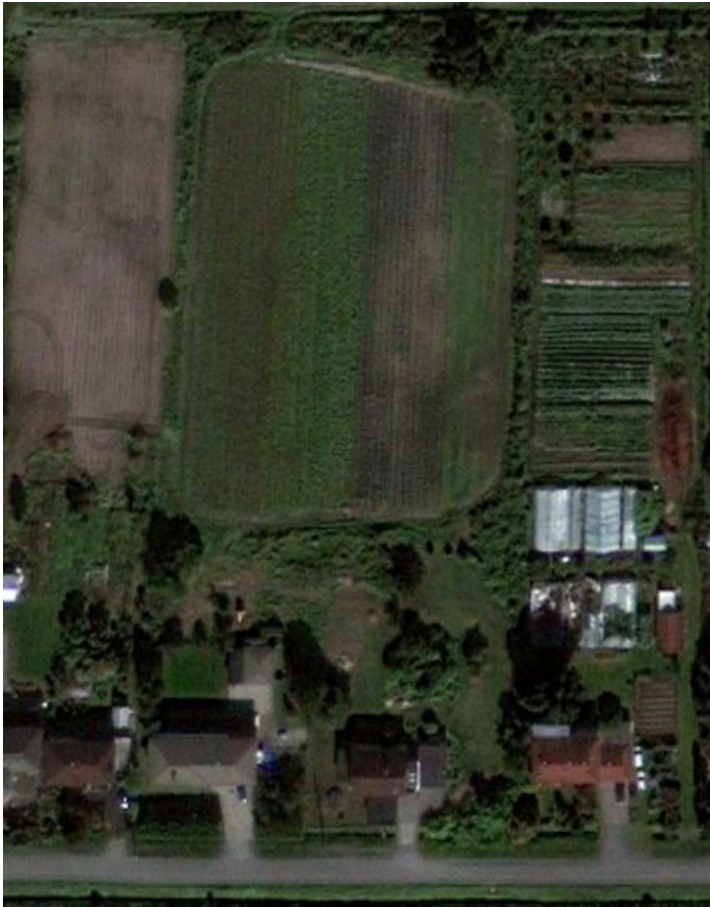
This is the aerial view of the Monteith farm in 2009

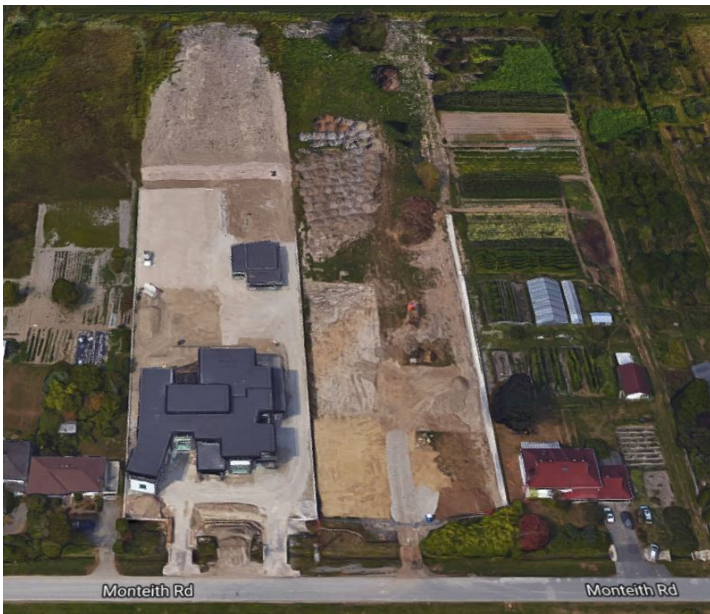
This is the soil disturbance from the fill and the mansion and the property is no longer farmed.

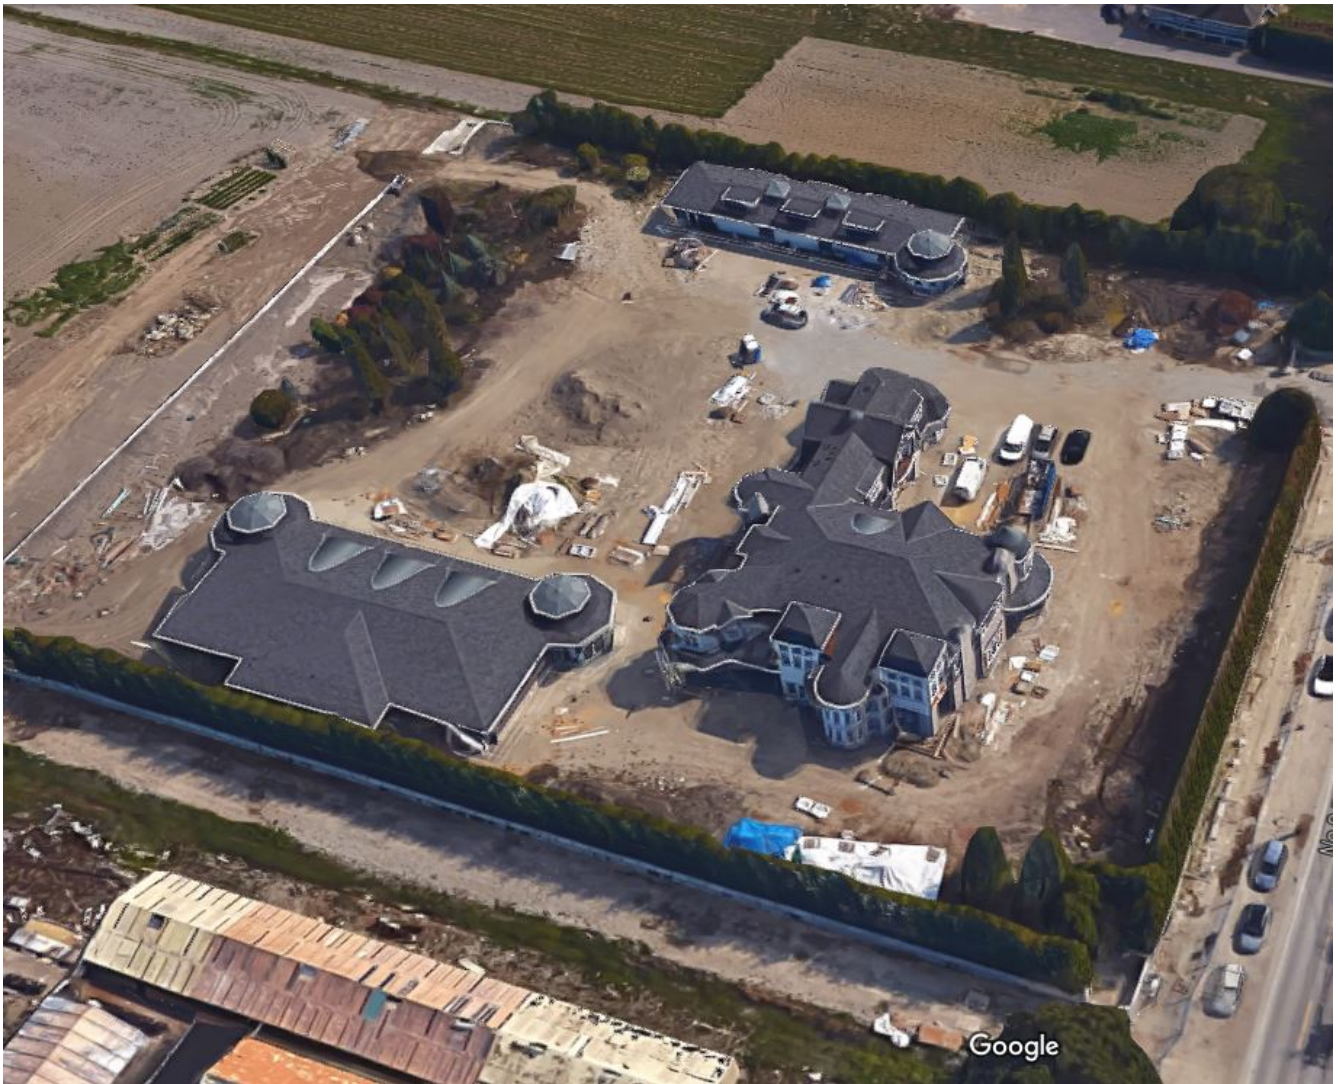
This is a typical home plate for mansions built prior to the bylaw change in May 2017. The city was permitting soil disturbance of areas well over double the ALC limit of 2000m².

This highlights the need for the ALC permitting for all construction on ALR.
